RE: Repealing and Readopting with Amendment the  
*Calvert County, Maryland Historic District Design Guidelines*

## Calvert County, Maryland Historic District **DESIGN GUIDELINES**

**Exhibit A**

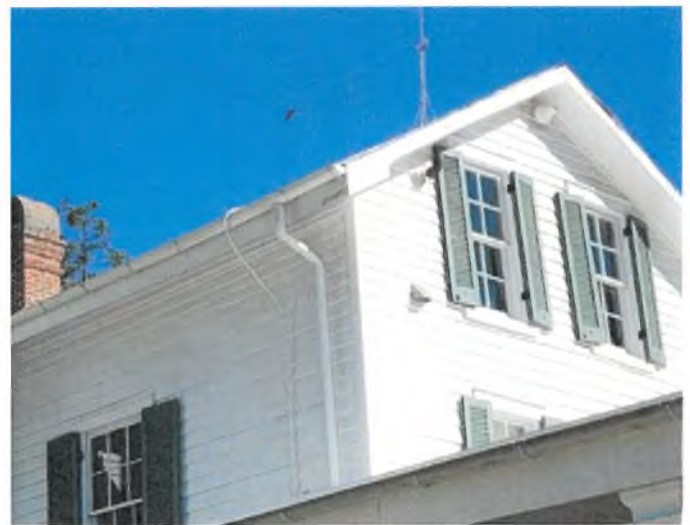
*The half-round gutters and smooth round downspouts of Linden (also known as the John Gray House), Prince Frederick are in keeping with the character of the Historic District.*

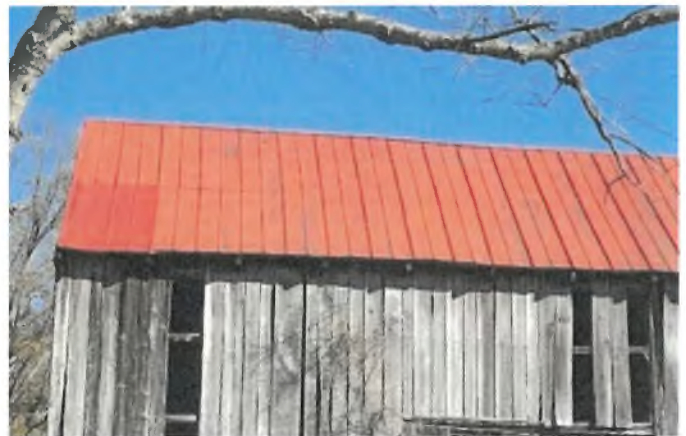
The metal roof of this tobacco barn at Cedar Hill, Prince Frederick has been patched and repaired. Image courtesy of Calvert County.

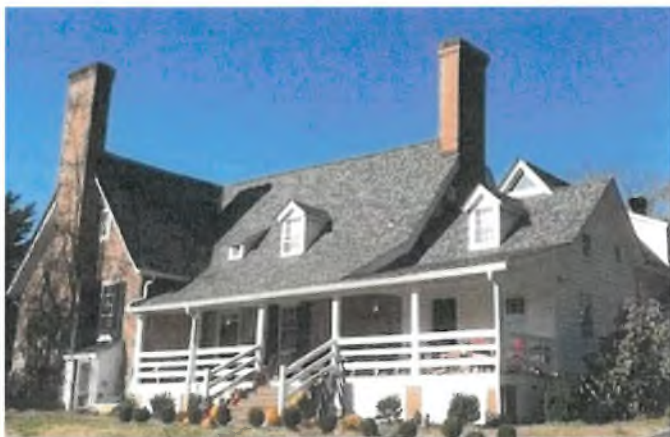
The roof of the main house at Cedar Hill, Prince Frederick has new asphalt shingle roofing to replace the previous asphalt shingle roof. Image courtesy of Calvert County.

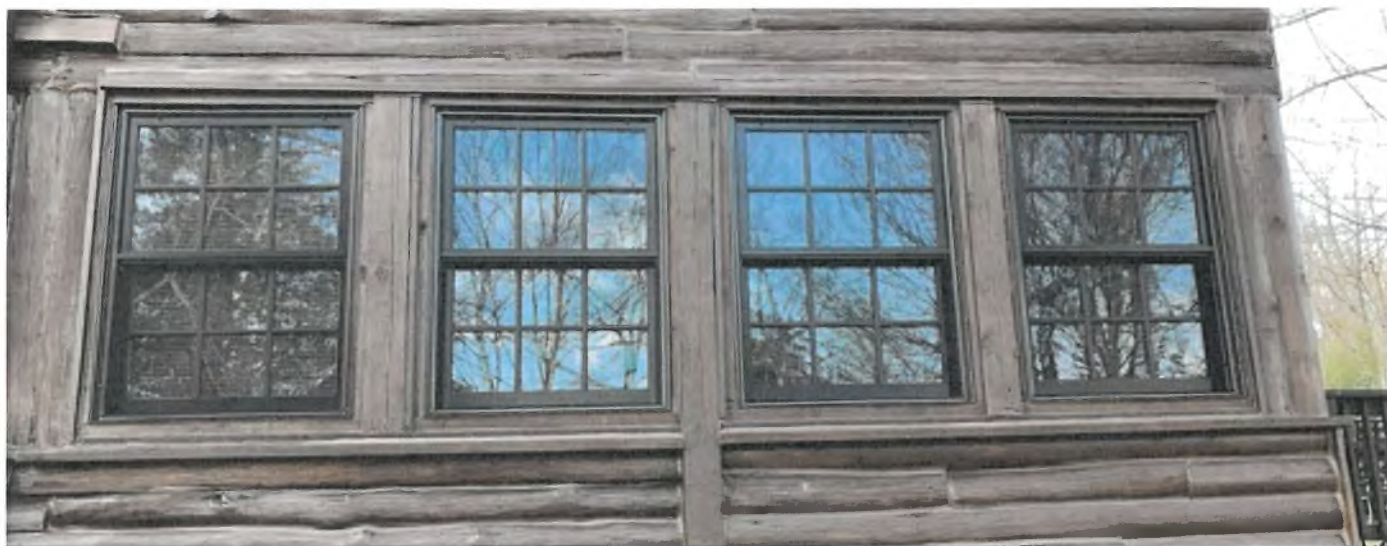
*Replacement windows at the Schultz Cabin, Port Republic. Image courtesy of Calvert County.*

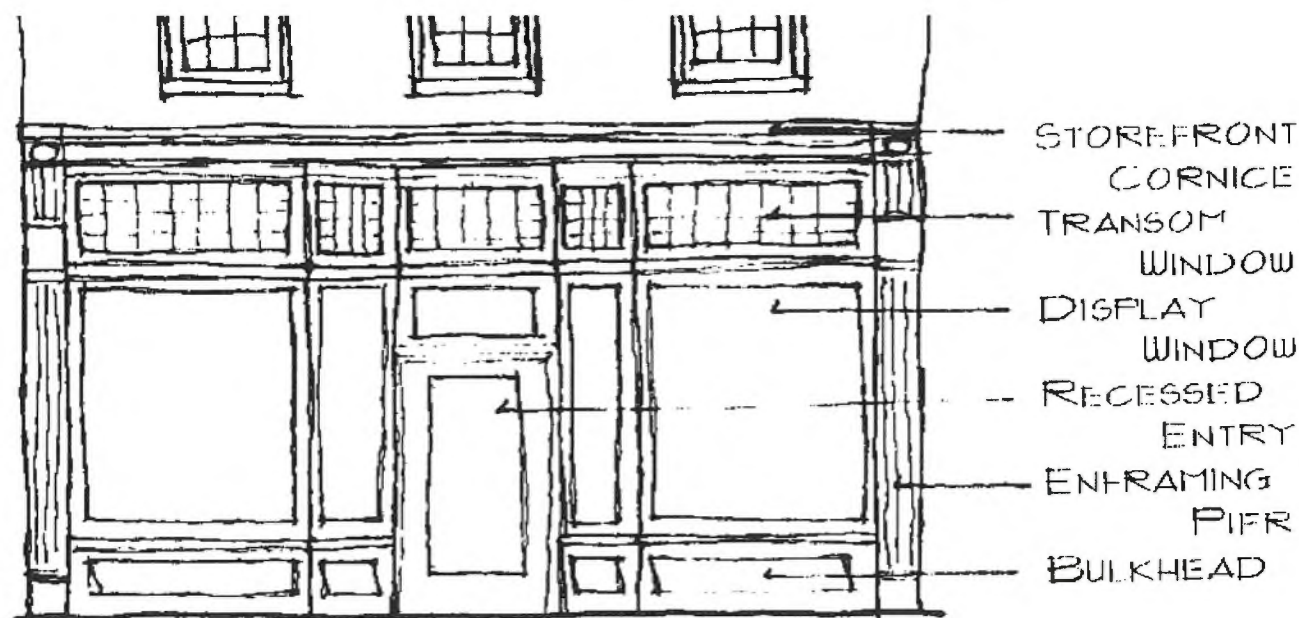
Elements of historic storefronts. Image courtesy of Calvert County.

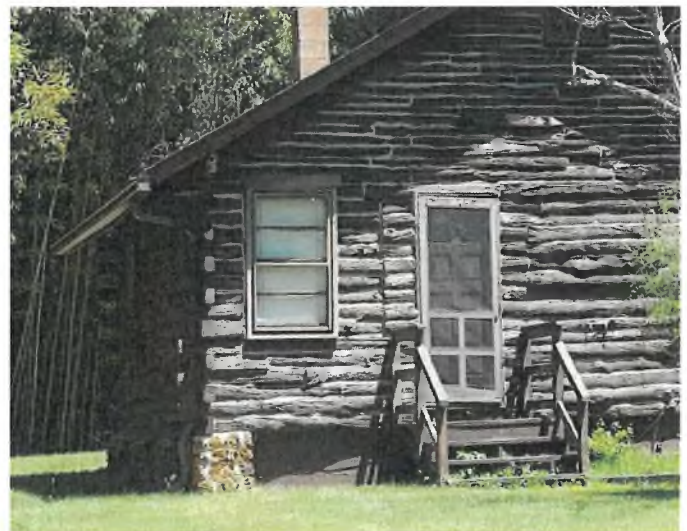
*This log home near Port Republic is constructed on stone pier foundations.*

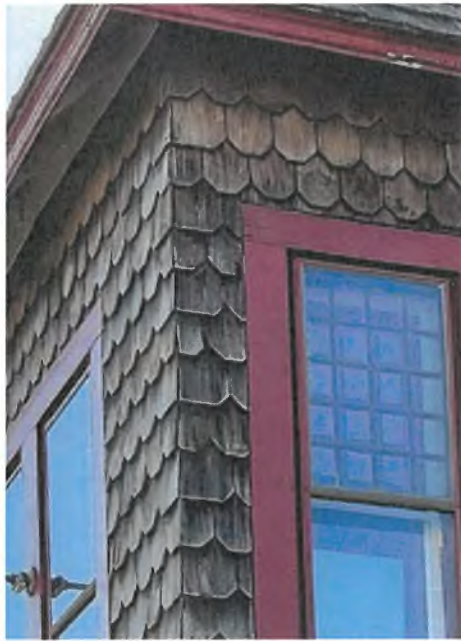
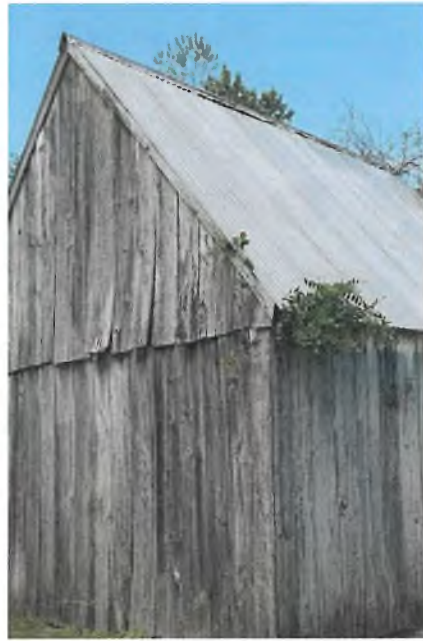
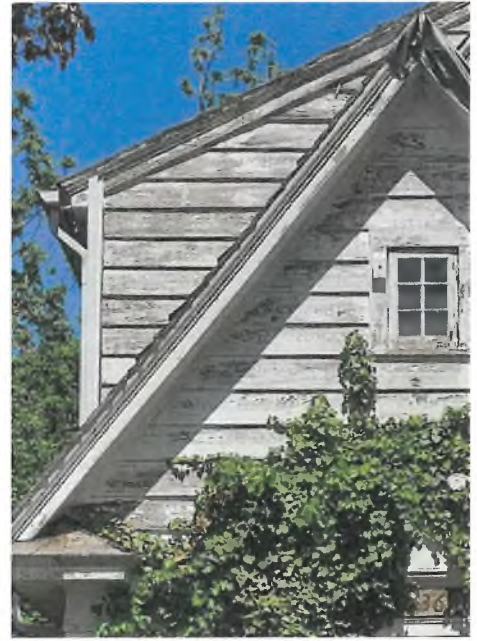
*Different types of wood siding from around Calvert County.*

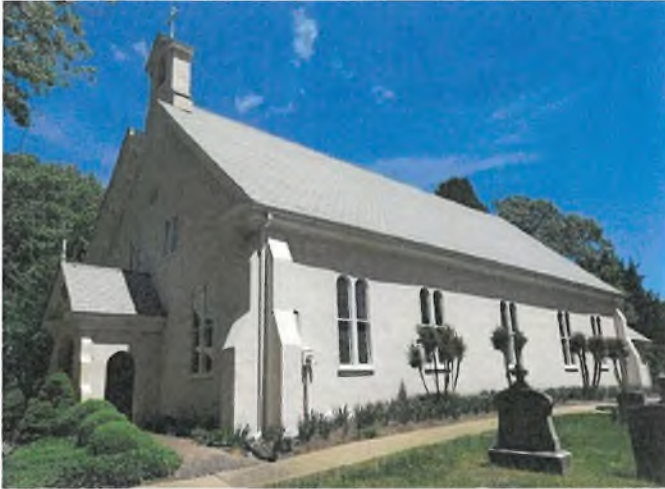
The brick walls of Christ Church, Port Republic were stuccoed over in 1906.

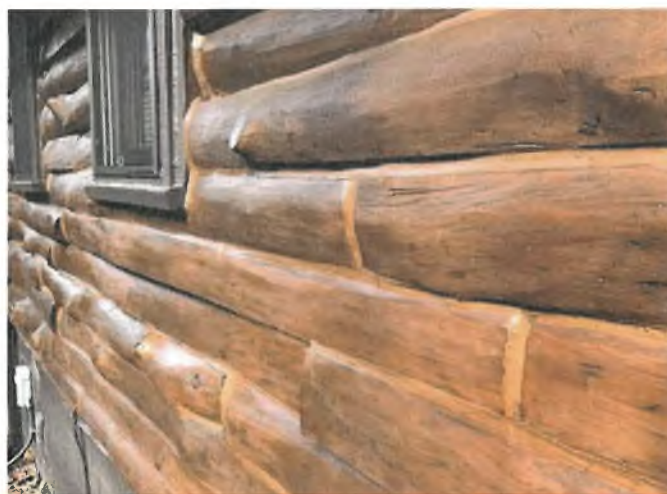
*Log repair work at the Schultz Cabin, Port Republic. Image courtesy of Calvert County.*

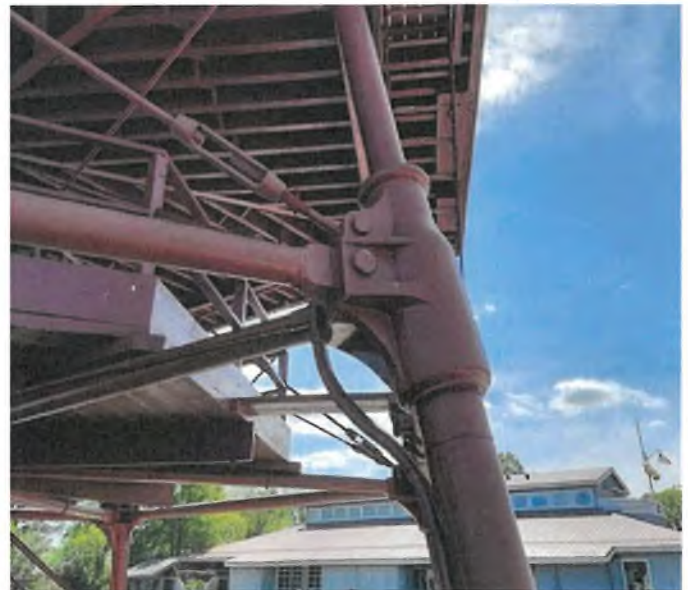
*Exposed metal structure of the Drum Point Lighthouse, Solomons.*

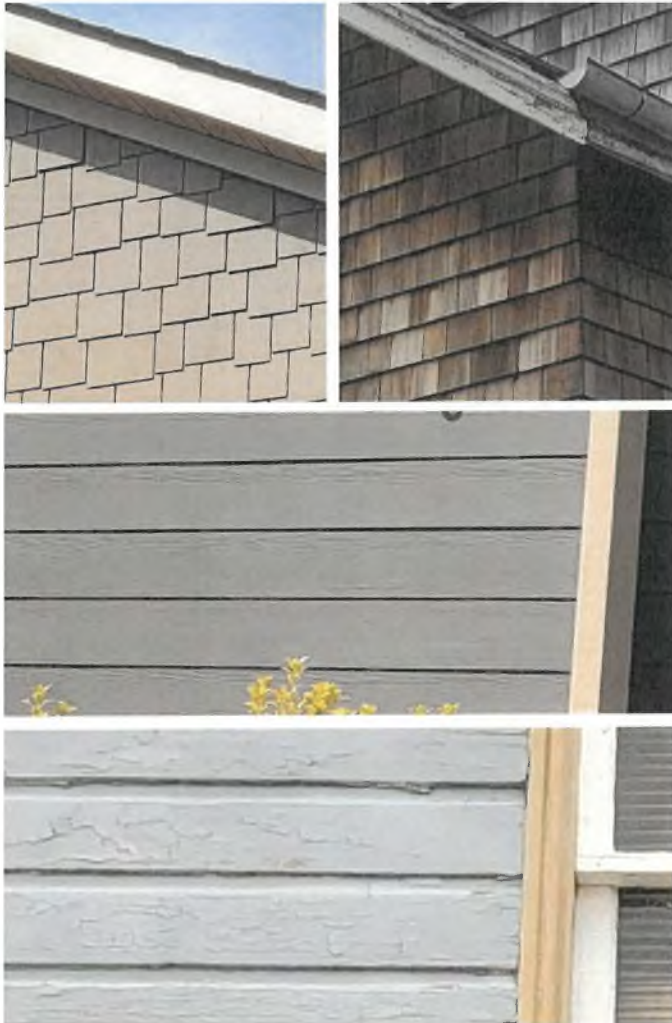
*Examples of synthetic materials that are not a good match for traditional materials. Upper left, synthetic shingles are too thin and flat; middle, synthetic siding profile is too narrow and the applied texture does not replicate wood boards well.*

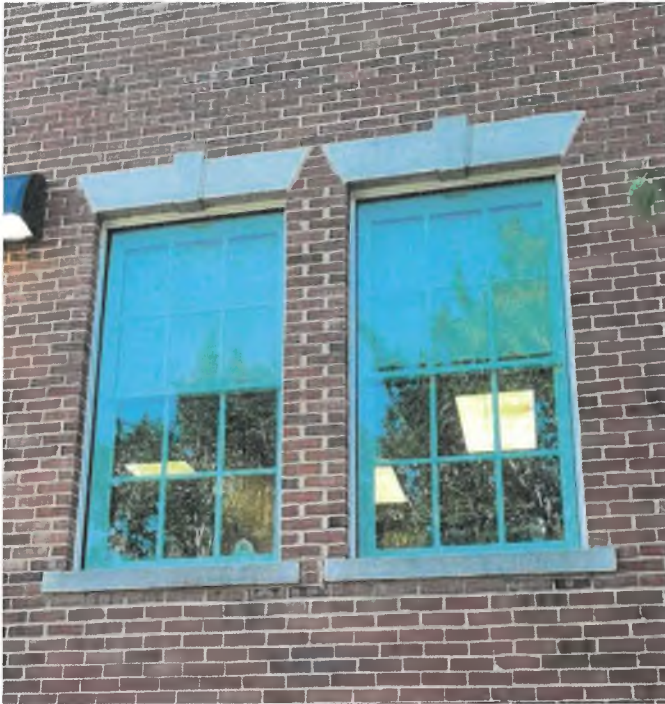
*These exterior storm windows do not have any rails to obscure the view of the windows inside.*

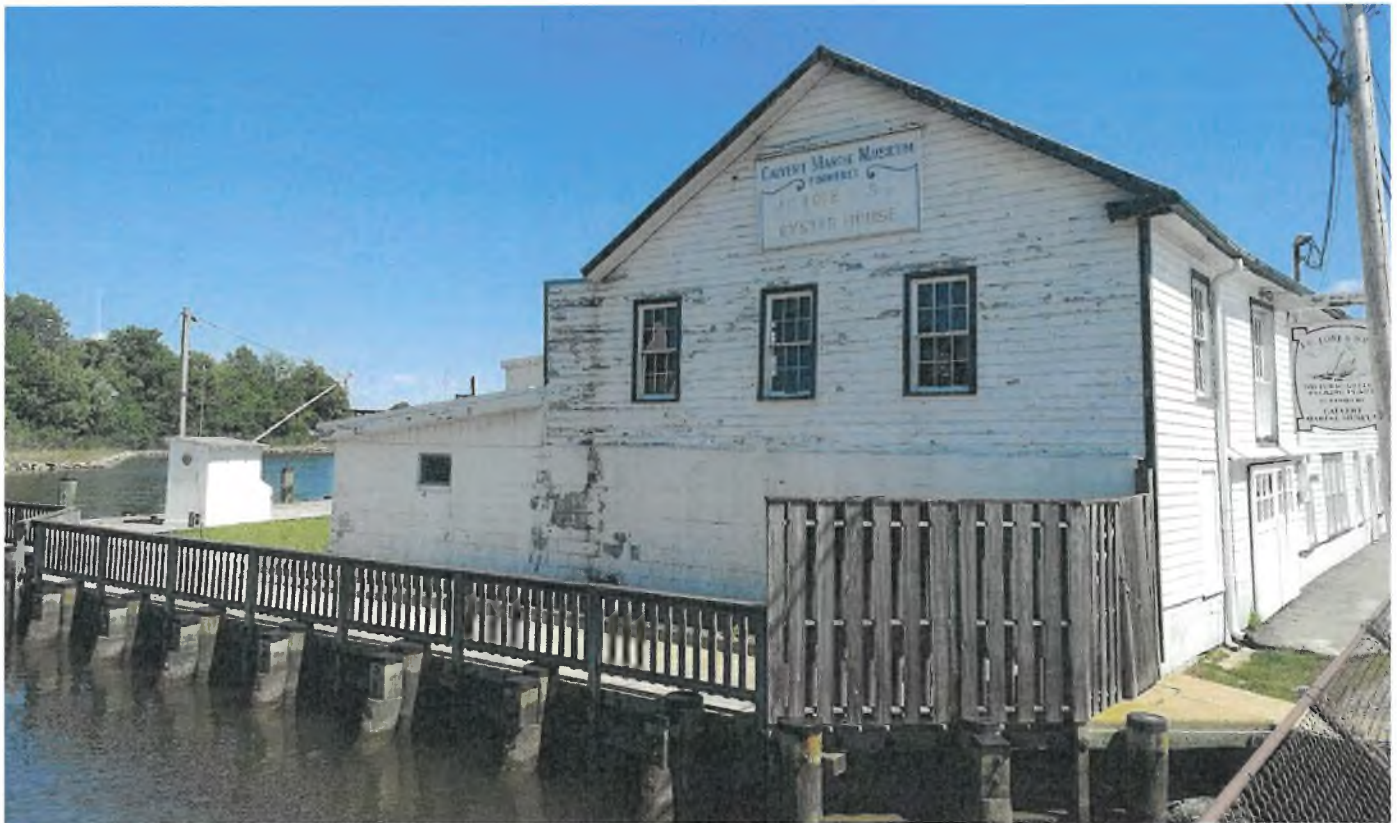
*J.C. Lore Oyster House, Solomons sits directly on the Patuxent River and is subject to flooding. The base of the walls up to the bottom of the first-floor windows are constructed of concrete to help withstand the effects of flood water.*

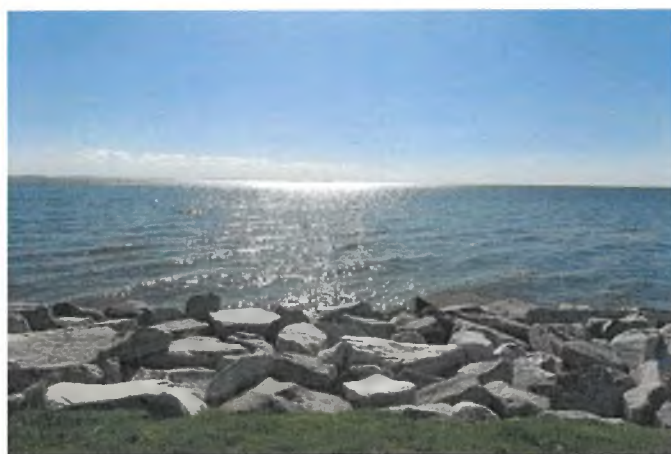
Stone revetment along the shoreline of the Chesapeake Bay at Chesapeake Beach.
